Attitude Indicator

Quarterly Safety Newsletter

False Localizer Capture

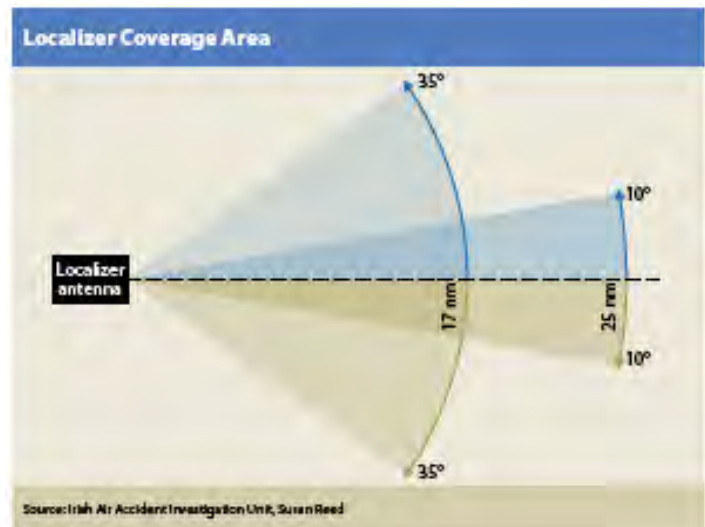
The localizer was armed while the aircraft was outside the specific localizer coverage sector;

- “The captain commenced a descent’ without having a valid ILS [instrument landing system] signal and without cross-checking other available navigational aids [and]
- The situational awareness of the controller in Kerry Tower, was compromised by erroneous position reports from the crew and noncompliance with his instructions, as well as a lack of direct radar information”

Both navigation displays were in the weather radar map mode. If at least one of the displays had been in the EGPWS map mode, the pilots might have realized that they were heading toward terrain rising above 3,000 ft in their Flight Path instead of tracking the final approach path.
